TRANSPOWER

Ōtāhuhu – Whakamaru A&B lines reconductoring – Auckland wider region section

Attachment 1: Condition Assessment Report

December 2025

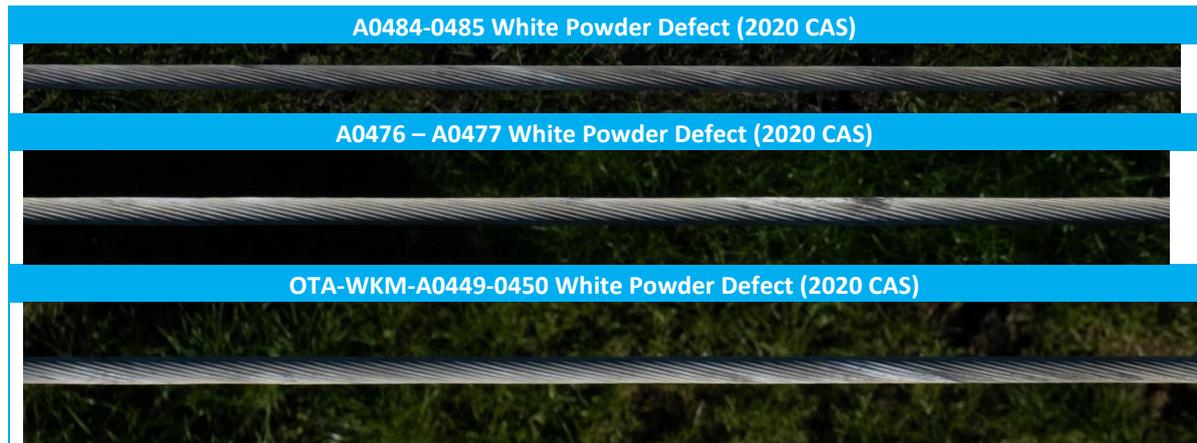
The Stage 2 segment of OTA–WKM–A, spanning T489 to T407, remains strung with the original 1952 Goat ACSR–GZ conductor. Our annual programme of CAS inspections using RPAS identified widespread white powder defects throughout the section of line. Examples of these defects are shown in Figure 3.

Figure 3. Example of white powder defects found on the Stage 2 section of the OTA–WKM–A line

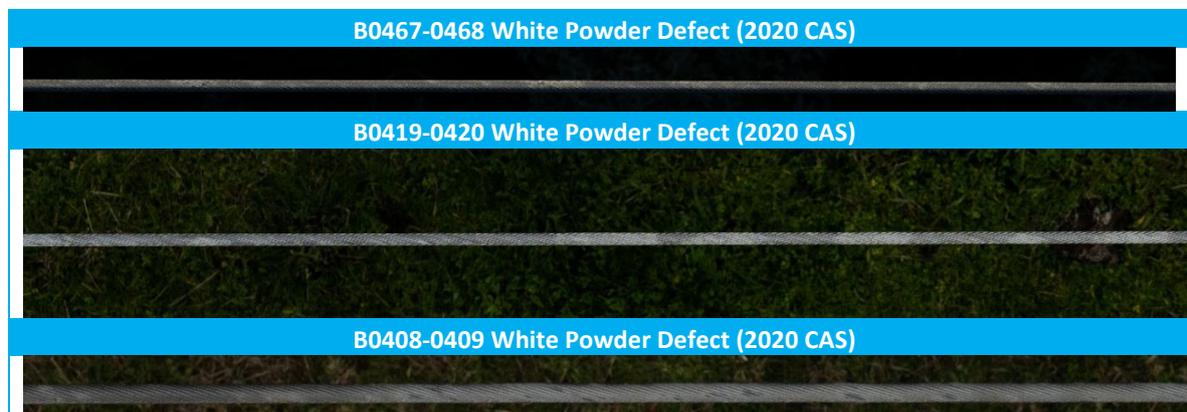
The Stage 2 section of OTA–WKM–B, from B0469 to B0391, is strung with the original 1954 Goat ACSR–GZ conductor. CAS inspections have identified widespread white powder defects throughout this section of line, examples of which are shown in Figure 4, indicating advanced corrosion of the steel core and sacrificing of aluminium cross-section.

Figure 4. Examples of white powder defects found on the Stage 2 section of the OTA–WKM–B line

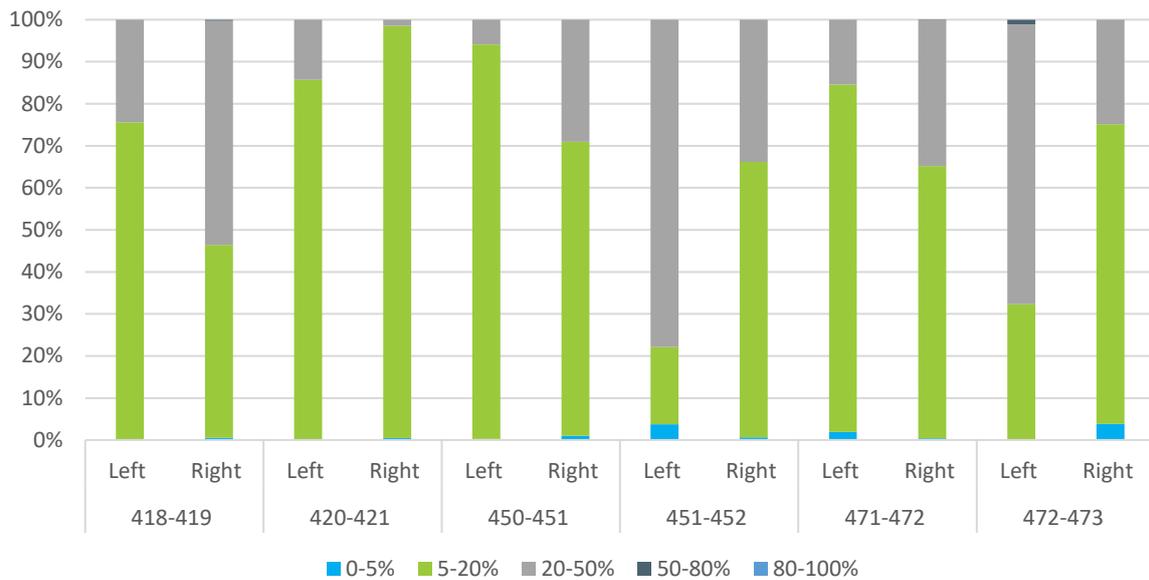
Figure 5 and Figure 6 show the estimated coating loss in spans which were included in the 2016 eddy-current testing programme. Overall, the OTA–WKM–A line has more advanced coating loss than the B line, including some localised areas of very high coating loss in spans 471-473 which could indicate grease defects. On both the OTA–WKM A&B lines, there were a few spans with widespread coating loss, such as the right phase of 430-431 on the B line and the left phase of 451-452 on the A line. As eddy-current testing is only performed on a handful of spans, there are likely a number of spans with similarly widespread coating loss.

Figure 5. Estimated coating loss by span and phase (left or right) in Stage 2 section of the OTA-WKM-A line

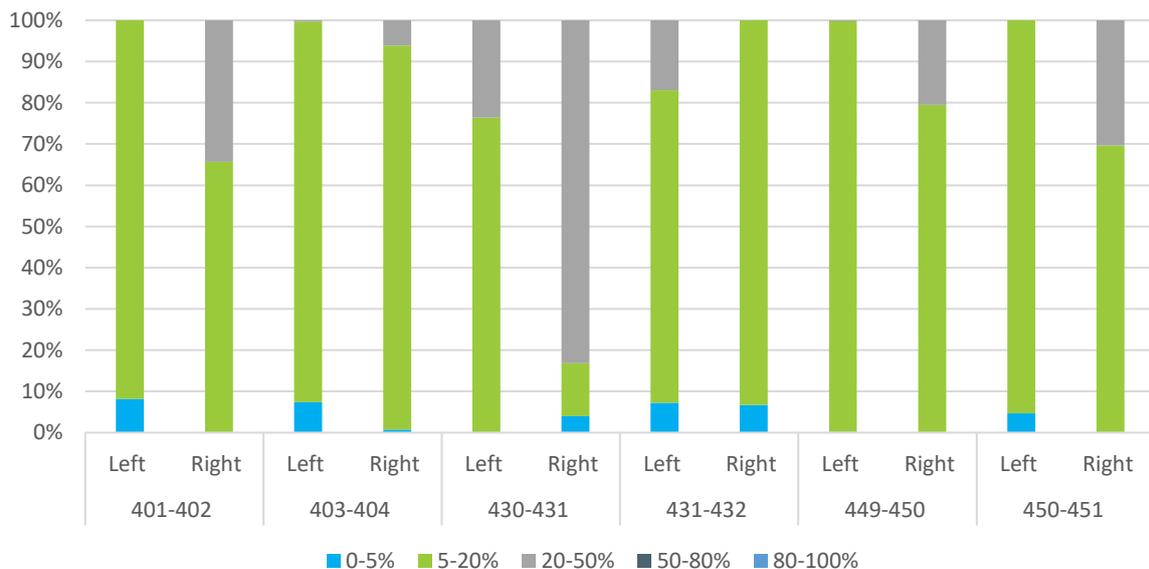
Figure 6. Estimated coating loss by span and phase (left or right) in Stage 2 section of the OTA-WKM-B line

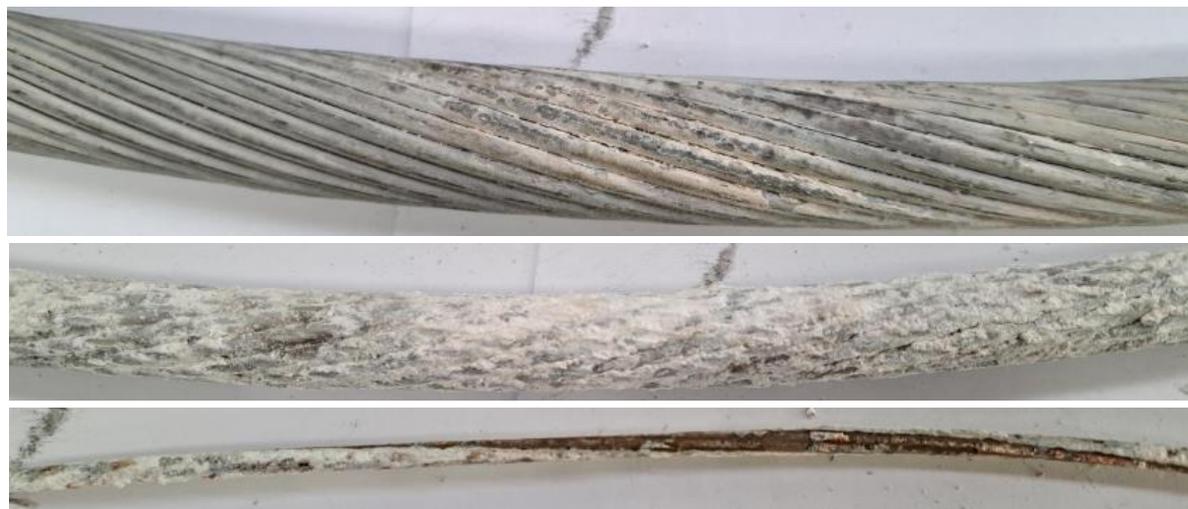
Figure 7 and Figure 8 show CAS images of two white powder defects which were cut from the line and sent for sampling in 2024. Overall, these samples had sufficient mechanical strength due to the high contribution of strength from the steel core, but the aluminium layers had significantly reduced breaking strength, indicating loss of section due to galvanic corrosion (Table 7). During testing, these two defects were confirmed as bulges; these had not been previously identified as such, either because they were small bulges which were misclassified during the CAS inspection, or because they developed to bulges since the CAS inspection. We were also able to see that the core steel had no galvanising along the length of the sample, as seen in Figure 9.

Figure 9. From top to bottom: outer layer bulge, inner layer corrosion, and core steel corrosion in the A0386 – 0387 span

Both samples retrieved from the Stage 3 section of the A line (Figure 7, Figure 8) had sacrificed the zinc galvanising layer on the core steel and galvanic corrosion had occurred between the steel and aluminium layers (Figure 9), resulting in reduced breaking load due to loss of aluminium cross section (Table 7). We consider these samples to be representative of the condition of the ungreased conductor in the Stage 2 and 3 section of both lines, due to the proximity of the samples
