Independent Review of Catastrophic Event Remediation Expenditures

July 2024

Prepared for:
Firstlight Network Ltd
172 Carnavon Street
Gisborne 4010
Ph. 06 869 0700

Prepared by:
M W Consultants Ltd

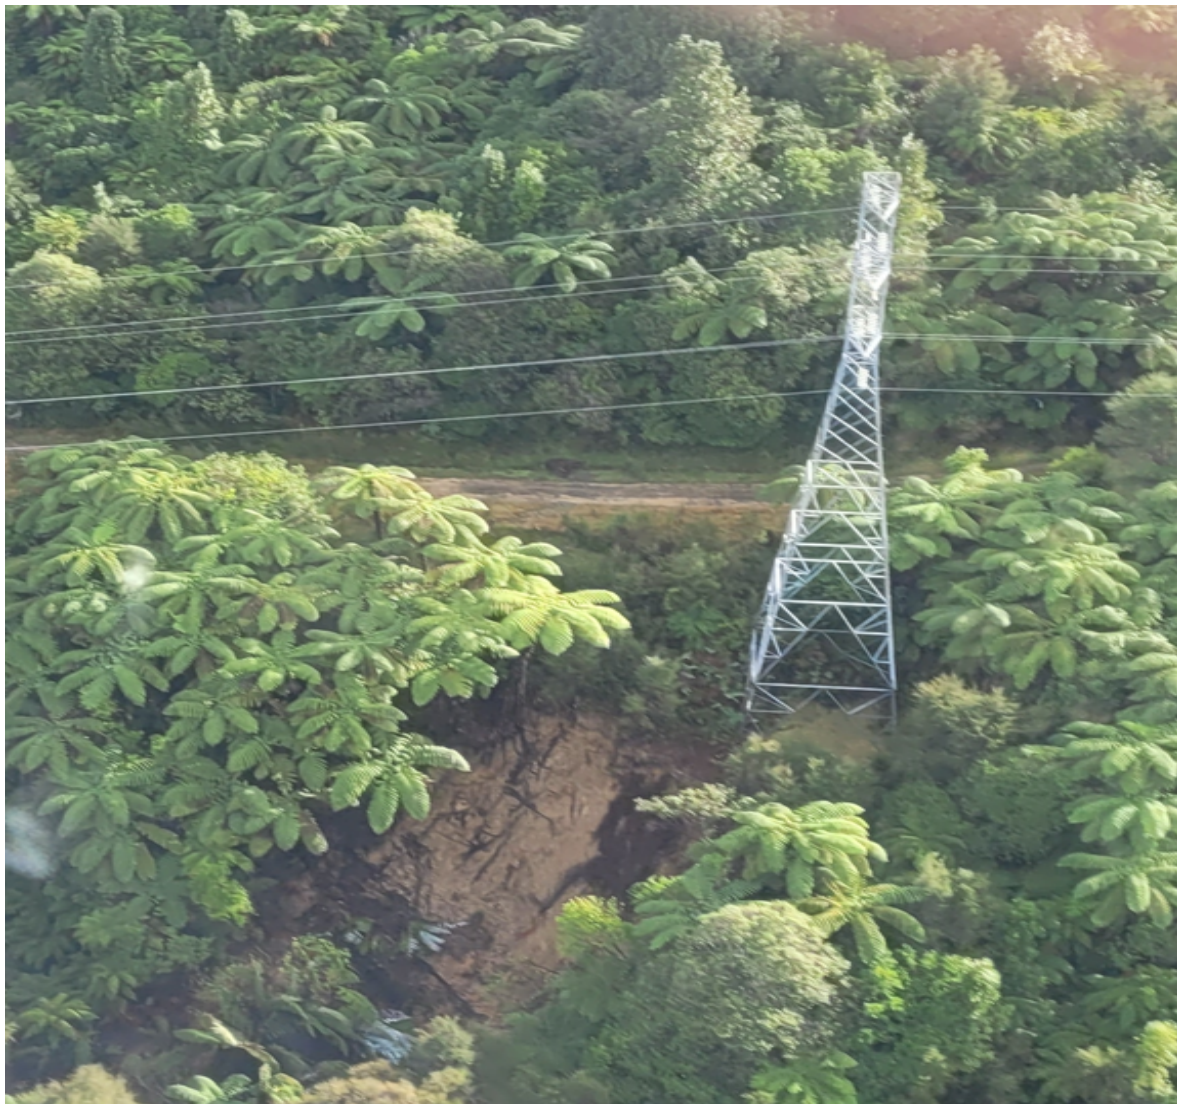
Figure 1: Gisborne/ Tuai Tower T11

RY2025 Capex Project Name	Assessed Risk	Recommendation
T11 Tower reinstatement	Intermediate risk – a vertical slip face of 12 metre depth within 1.5 metres of tower footing occurred during Gabrielle due to erosion from a stream below (refer to Figures 1 and 2).	Relocate GIS/TUI T11 tower to nearby site and install tower foundation tie beams.
T142 Tower reinstatement	Intermediate risk – major slips above and around tower with cracks in ground across the tower foundations occurred on a scarred hillside as a result of Gabrielle (refer to Figures 3 and 4).	Geotechnical survey, planting and relocation of one circuit to a new structure on ridge.
T302 Tower reinstatement	Moderate risk – ground movement on hillside below the tower on a hillside near Gisborne substation due to Gabrielle (refer to Figure 5).	Ongoing tilt monitoring. Relocation of one circuit to new structure on nearby ridge.
T303 Tower reinstatement	Intermediate risk – several slips below and beside the tower occurred during Gabrielle (refer to Figure 6).	Full foundation reinstatement with drainage and retaining wall.

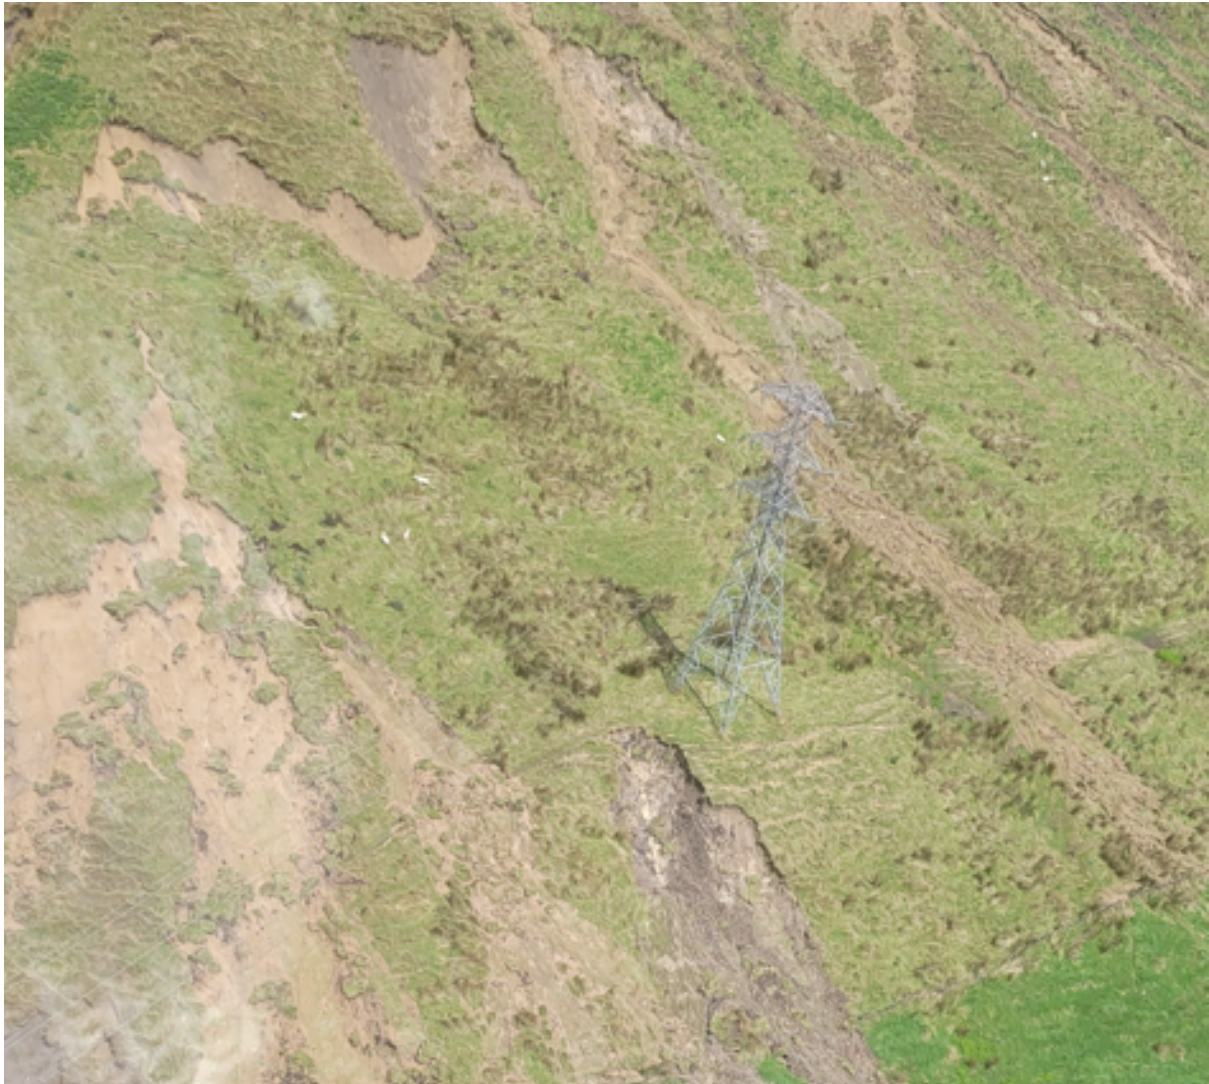
Figure 3: Gisborne/ Tuai Tower T142 in March 2023

T13 Tower reinstatement	High risk – Ground movement on south side of tower has exposed the bored piles on A and B legs during Gabrielle (refer to Figure 7).	Locate new site for tower relocation and undertake site civil works.
T102 Tower reinstatement	Intermediate risk – Land slip north of tower exposed 2 metres of bored pile on B leg during Gabrielle. Previous mitigations installed in 2022 failed (refer to Figures 8 and 9).	Locate and divert unidentified water sources and identify future tower relocation options.
B139 Bridge replacement	Enabling work for accessing Tower T142. This previous bridge completely washed away during Gabrielle (refer to Figure 13).	Deploy a replacement bridge.

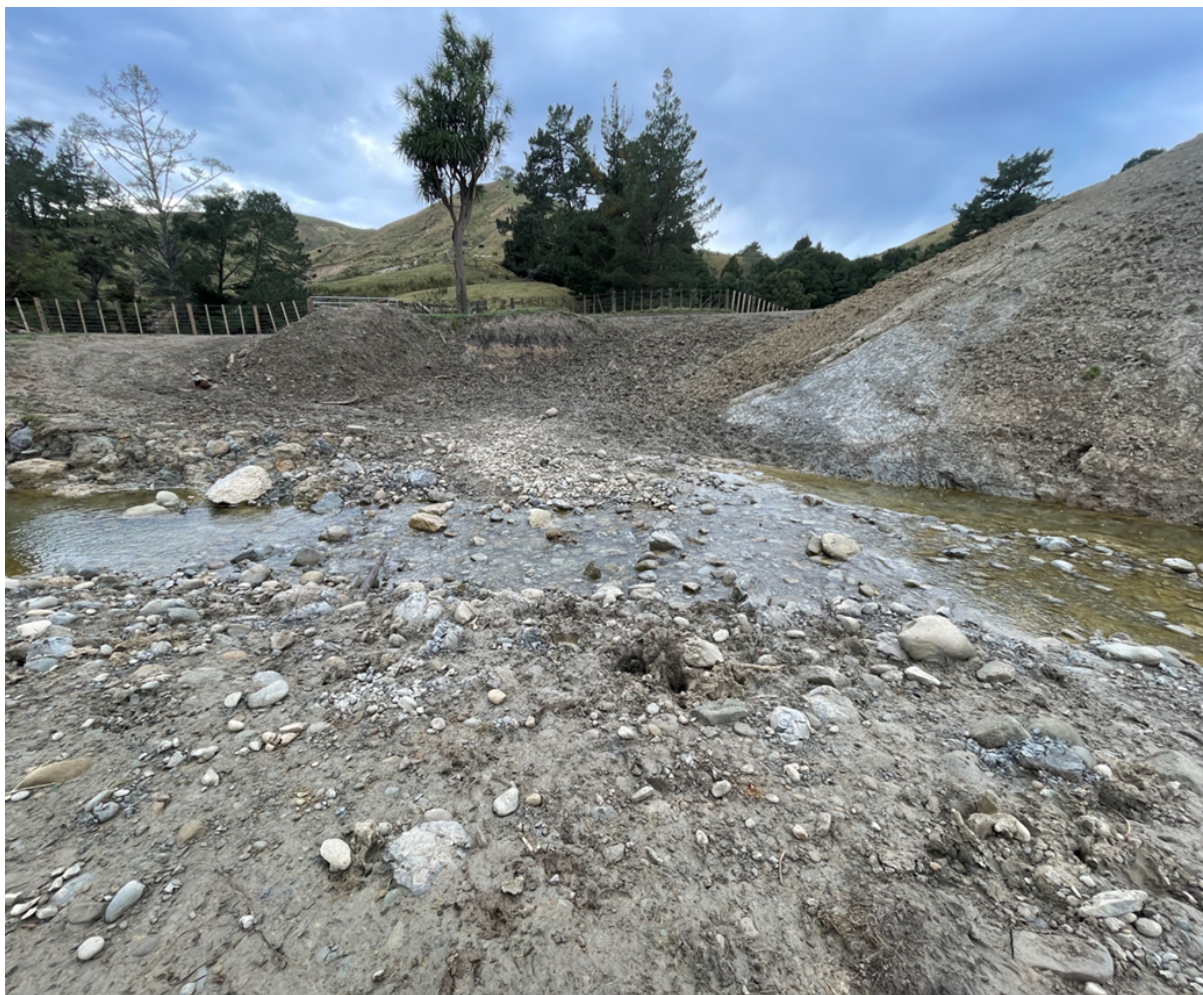
Figure 13: Bridge B139 completely washed away
