UPPER SOUTH ISLAND RELIABILITY MCP STAGE 1

ATTACHMENT E ISLINGTON SUBSTATION HILP EVENT STUDY

Transpower New Zealand Limited

June 2012

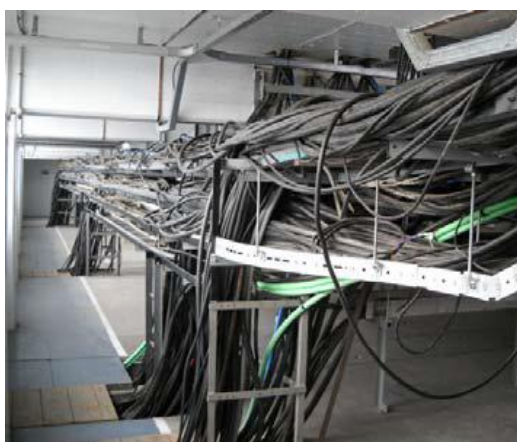
The consequences of a major fire in the cable basement could be catastrophic, potentially leading to loss of supply or severe rationing of supply to large parts of Christchurch and the upper South Island.

Islington cable basement – general view

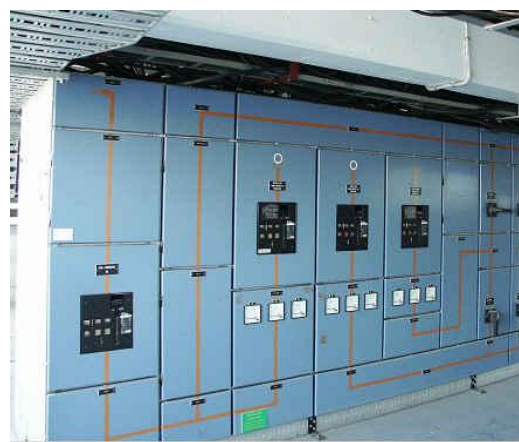
Main 415 V LVAC switchboard

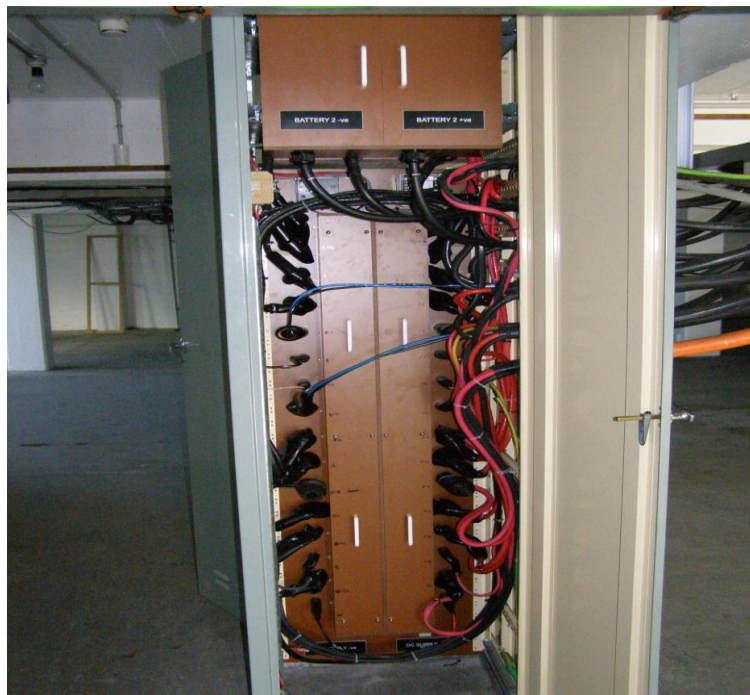
Loss of any of these facilities would have major implications.

The most critical of these is the 110 V dc system, because failure would immediately disable all switchgear protection and control. Transpower has no standard procedure for dealing with total loss of 110 V dc, and response would be slow and difficult.

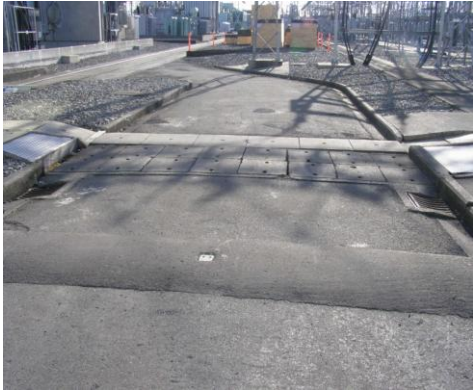
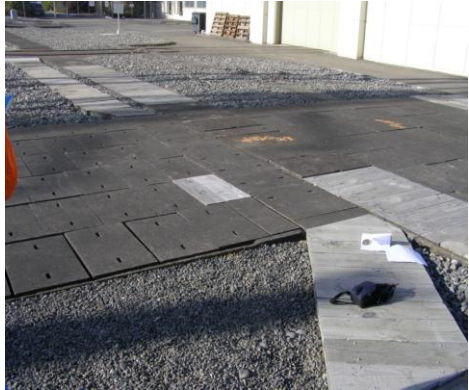
<p>All control and protection cables, from the 220 kV switchyard, are installed in these trenches beneath the main access route into the switchyard. There is a further crossing at the apron in front of the control building.</p>	<p>All control and protection cables, from the 220 kV switchyard, appear to cross 11 kV heavy power cable runs at this point. Details of cross-over to be photographed separately.</p>

The cable trenches crossing the main vehicle access route into the switchyard are densely packed with cables, and appear vulnerable to impact damage from above.

The crossovers of control and 11 kV power cables represent a potential point of major failure in the event of a power cable fire. Details of the crossover have not yet been obtained.
