TRANSPOWER

Cover image: The thyristor valve hall of the HVDC Pole 3 converter station at Haywards. The photo shows three quadrivalves each comprising a stack of high voltage thyristor assemblies with their associated cooling systems and surge arrestors.

This is Transpower New Zealand Limited's 23rd annual Quality Performance Report. It sets out operational performance data to assist our stakeholders to assess our performance against measures included in our 2013/14 Statement of Corporate Intent.

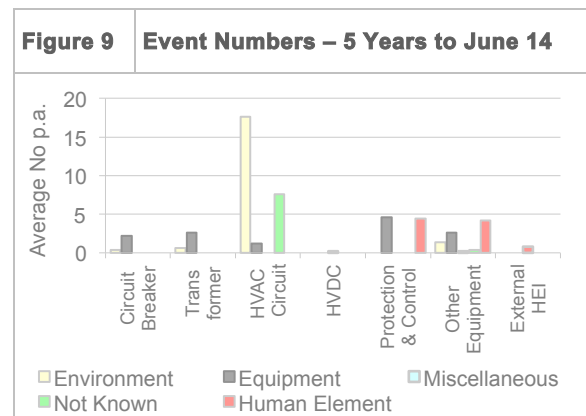
Figures 8 to 11 provide a further breakdown that takes into account the source (i.e. the item of equipment or initiating agent) of the non-supply event as well as the cause. Note that one event may comprise several interruptions. For example, a circuit fault on the Coleridge-Otira circuits caused interruptions at five different points of supply.

Figure 8 shows the numbers of events causing interruptions in 2013/14 and Figure 9 shows the five-year average number of events. Figure 10 and Figure 11 show a similar analysis for the system minutes of non-supply.
